ellison-auxier architects, inc.
924 francis
st. joseph, mo 64501
816.233.8003
fax 233.7793
ellisonauxier@sbcglobal.net

OBSERVATION REPORT

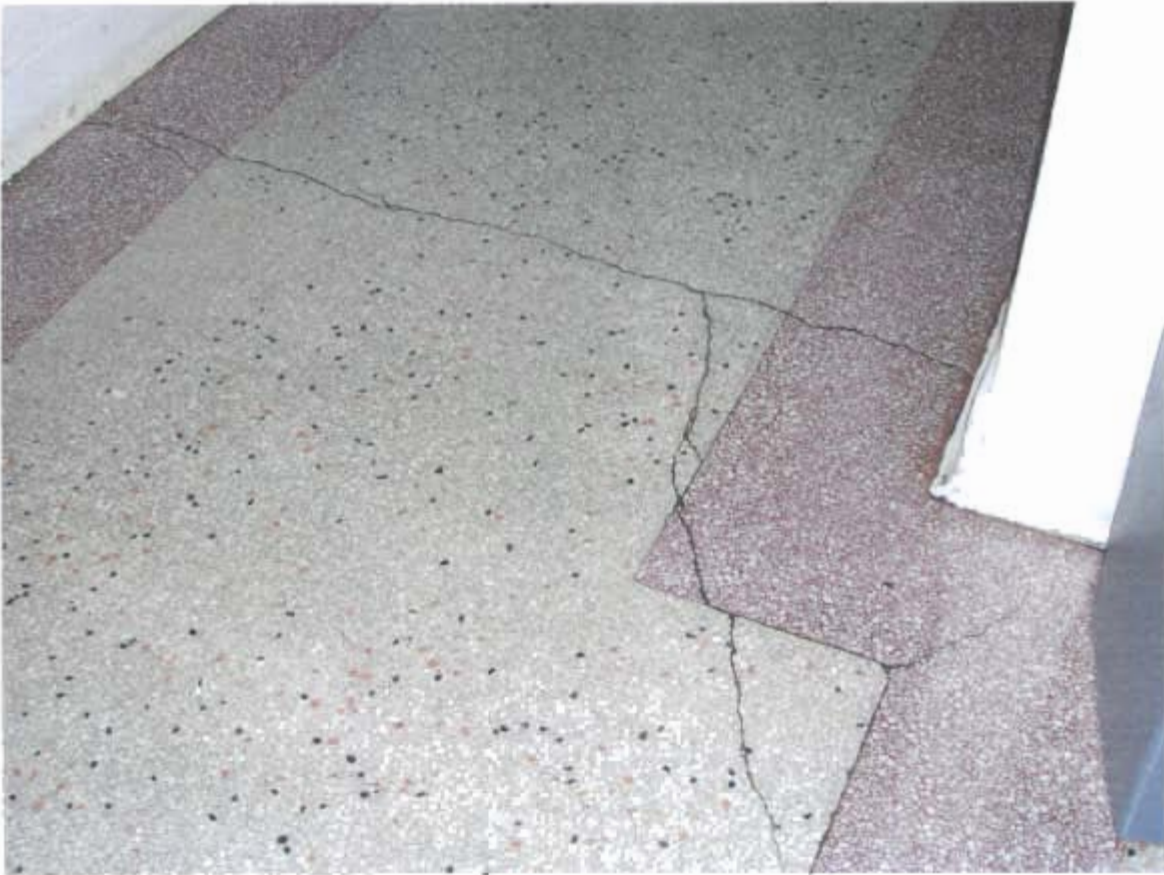
Photo #1: Random cracking in terrazzo floor at first floor near north stair.

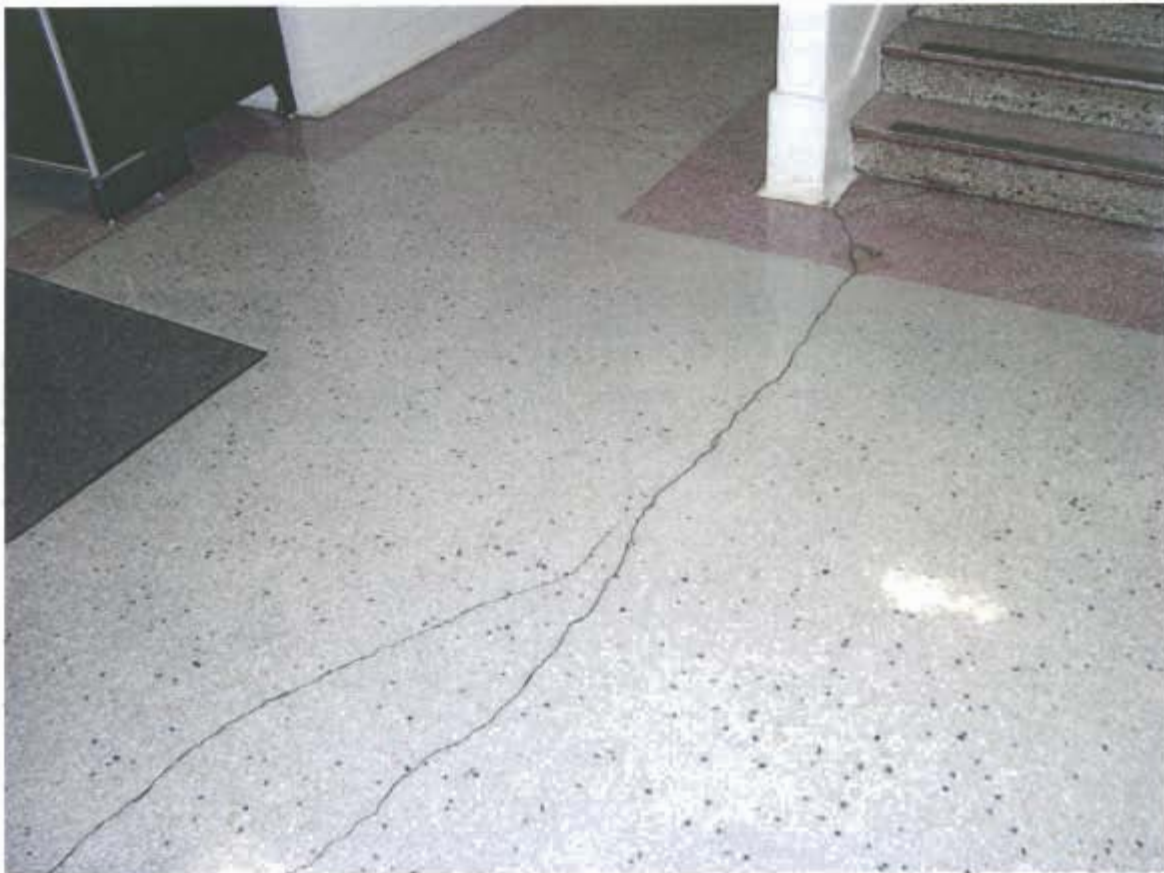
Photo #2: Random cracking in terrazzo floor at first floor near south stair.

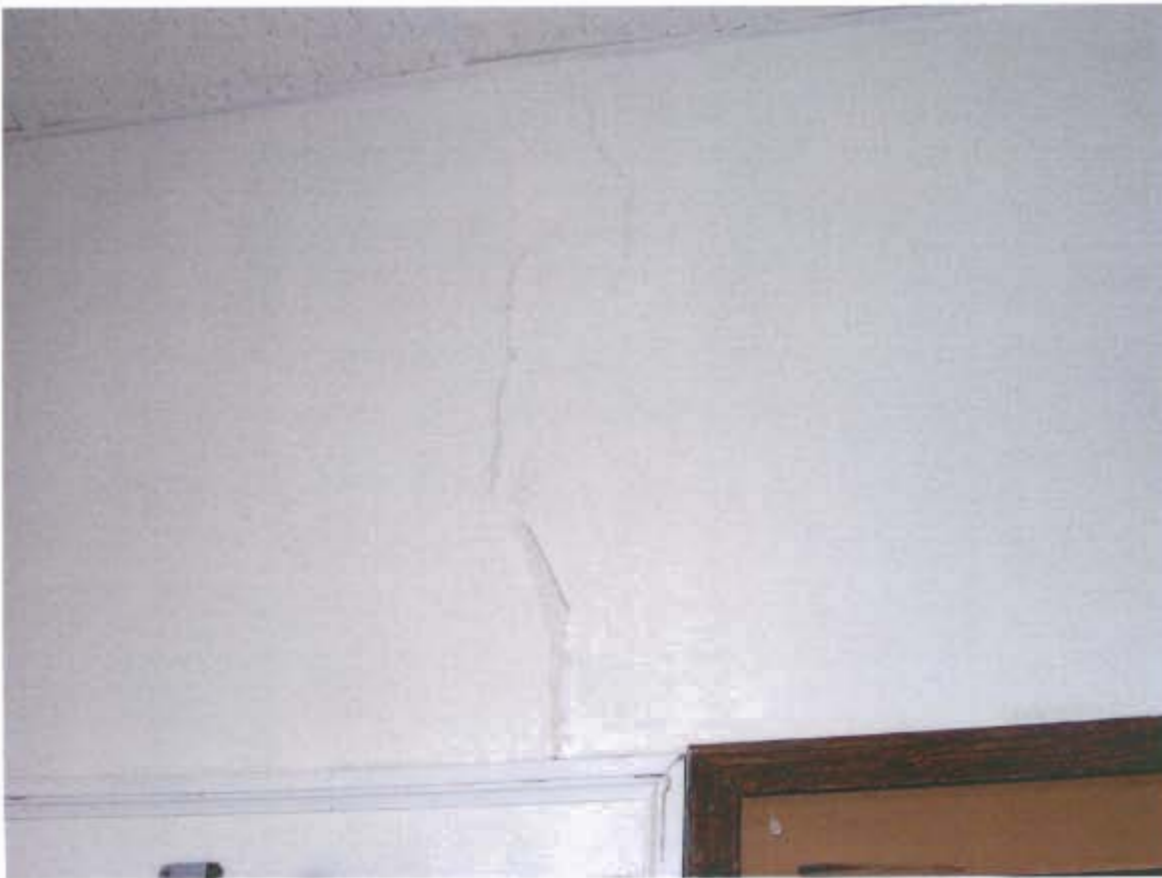
Photo #3: Vertical crack in plaster at first floor east corridor wall at south end. This occurs at this location at each floor.

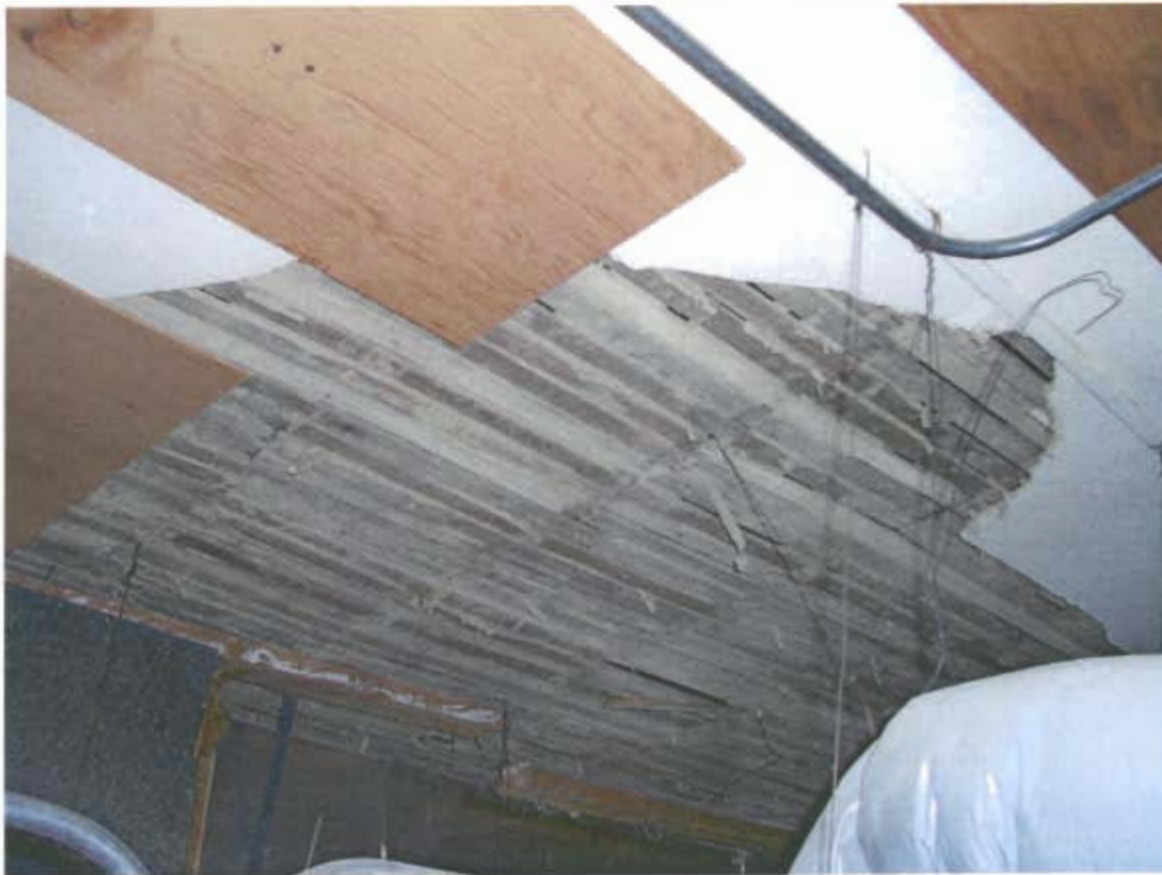
Photo #4: Falling plaster at first floor classroom ceiling (across from Library). Wood lath and plaster on 2x wood framing.

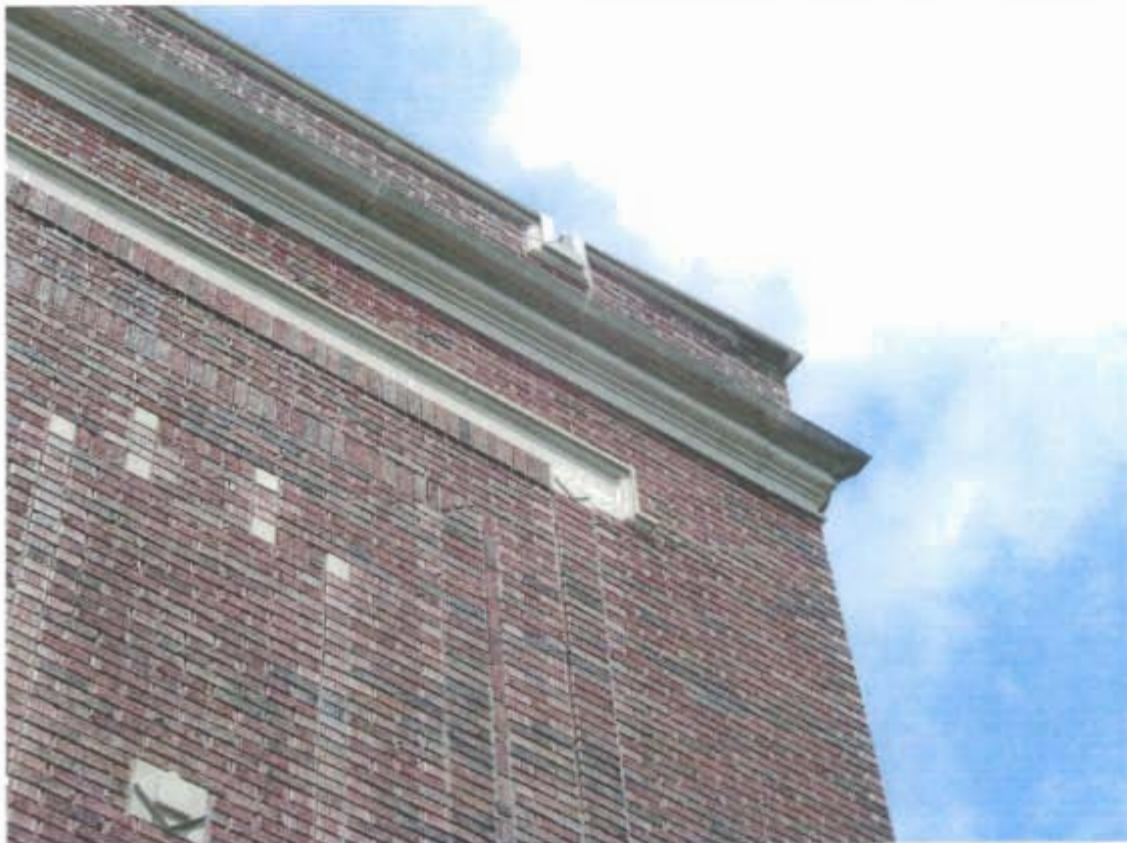
Photo #8: Southeast corner of building showing missing capstone at roof parapet. Metal roof cap was installed without replacement of stone cap.

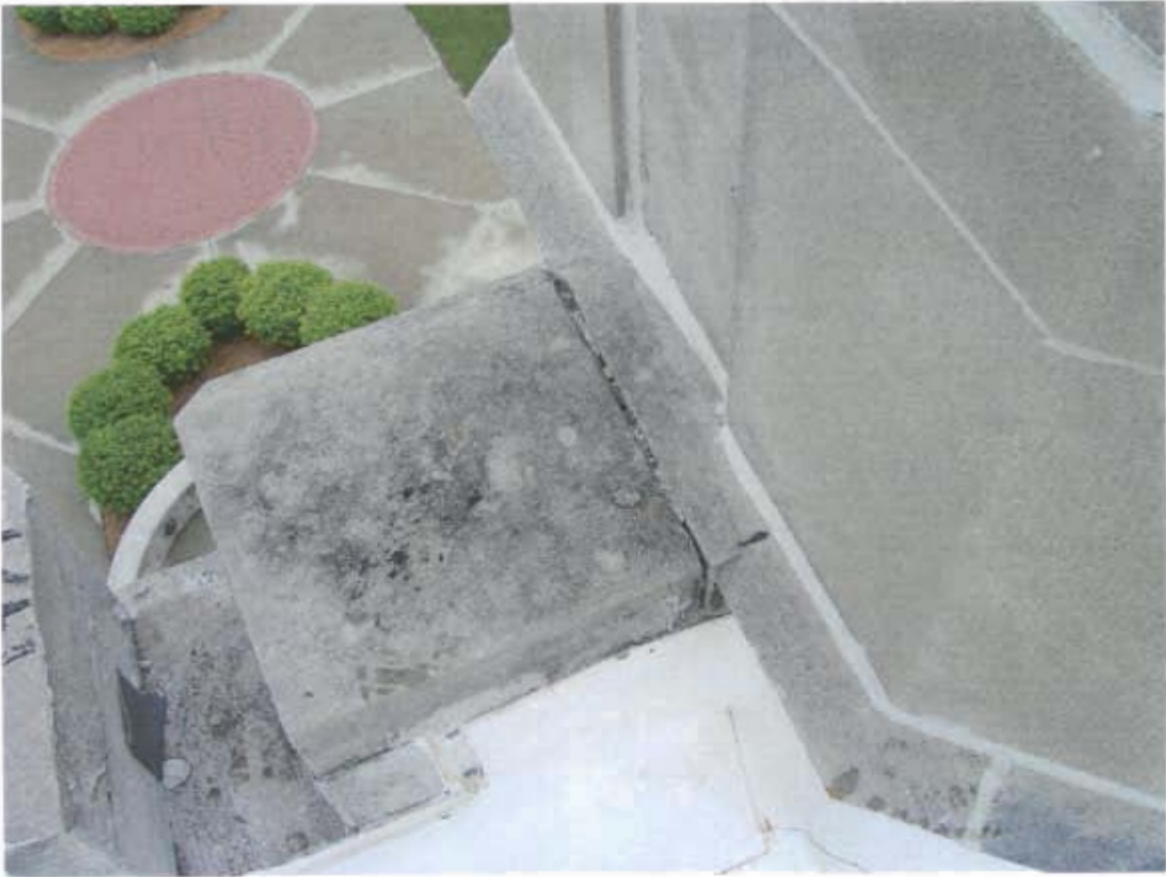
Photo #9: Failed caulk joint at stone cap between front entry towers.

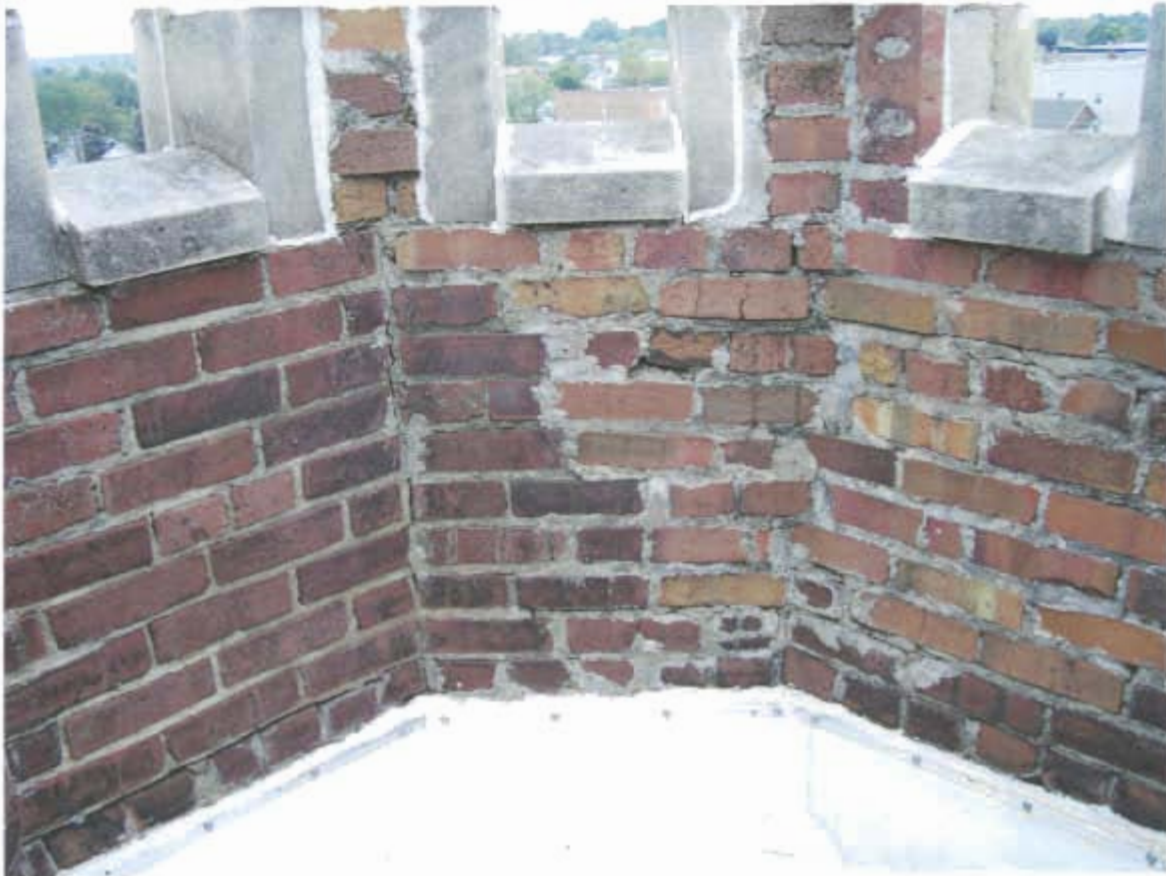
Photo #10: Failing mortar joints at inside face of front entry tower (above roof).

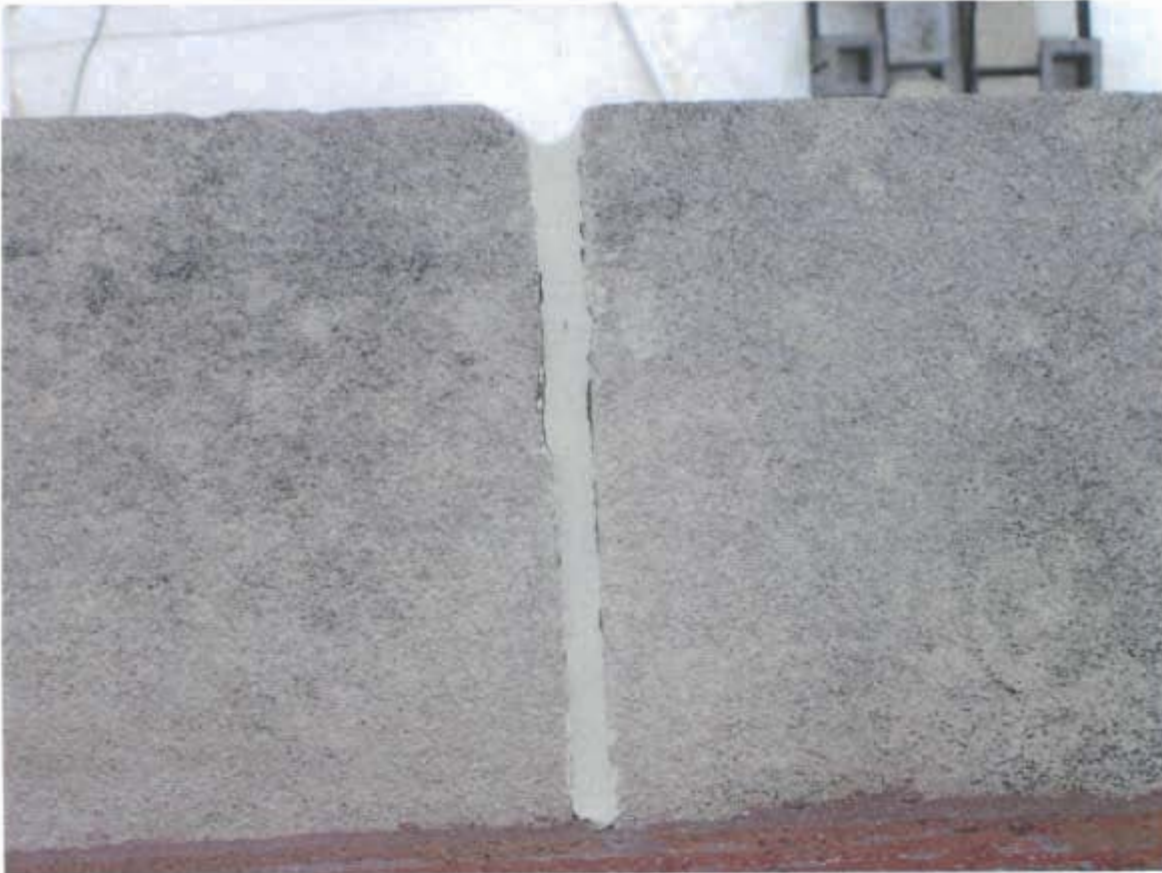
Photo #11: Failing caulk joint at stone band just below parapet.

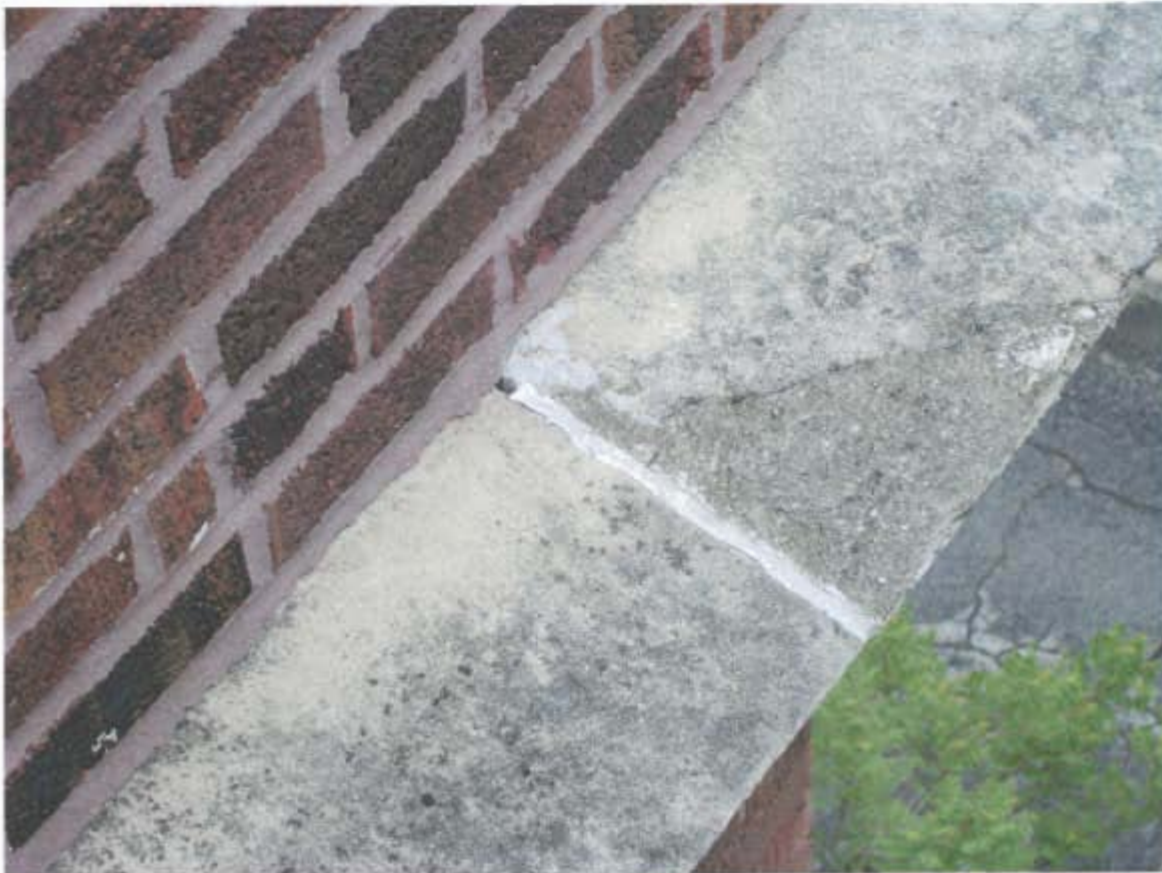
Photo #12: Failing caulk joint at perimeter stone band.

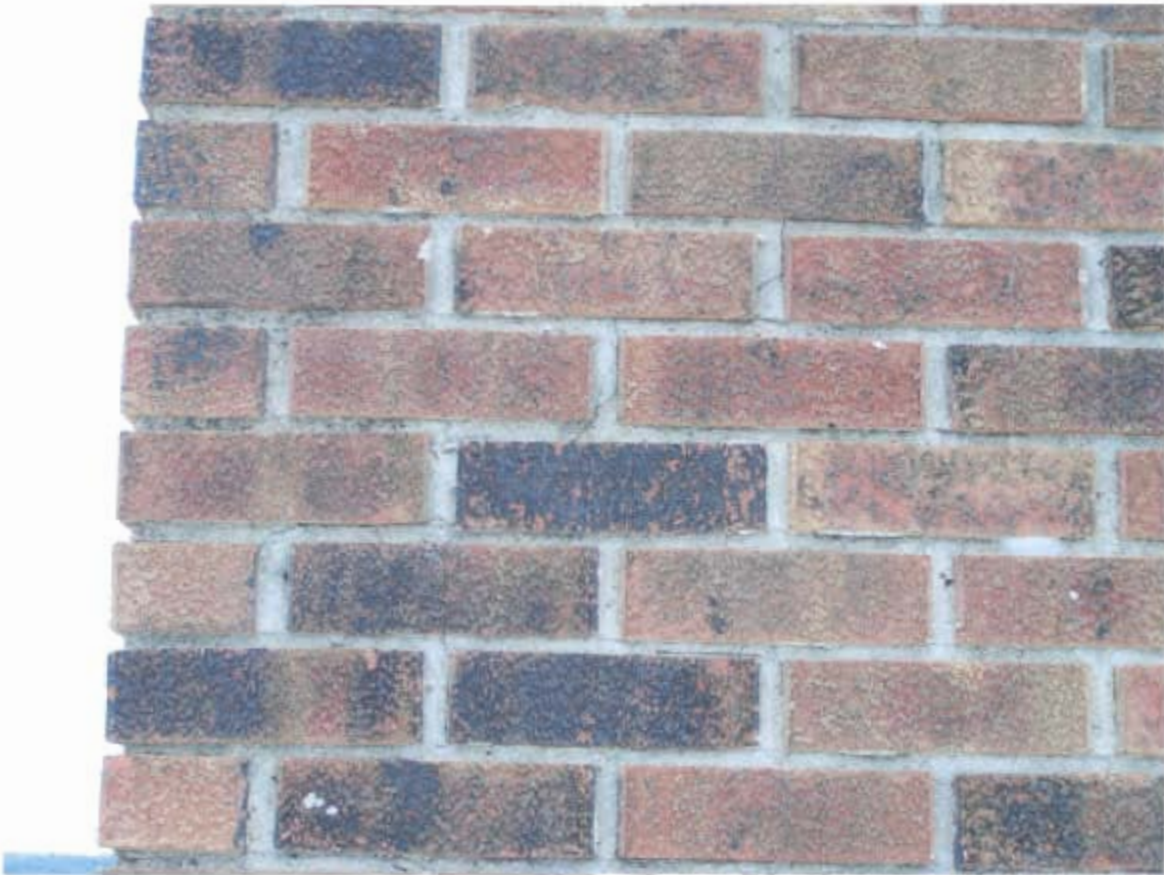
Photo #13: Diagonal crack in masonry veneer at west chimney.

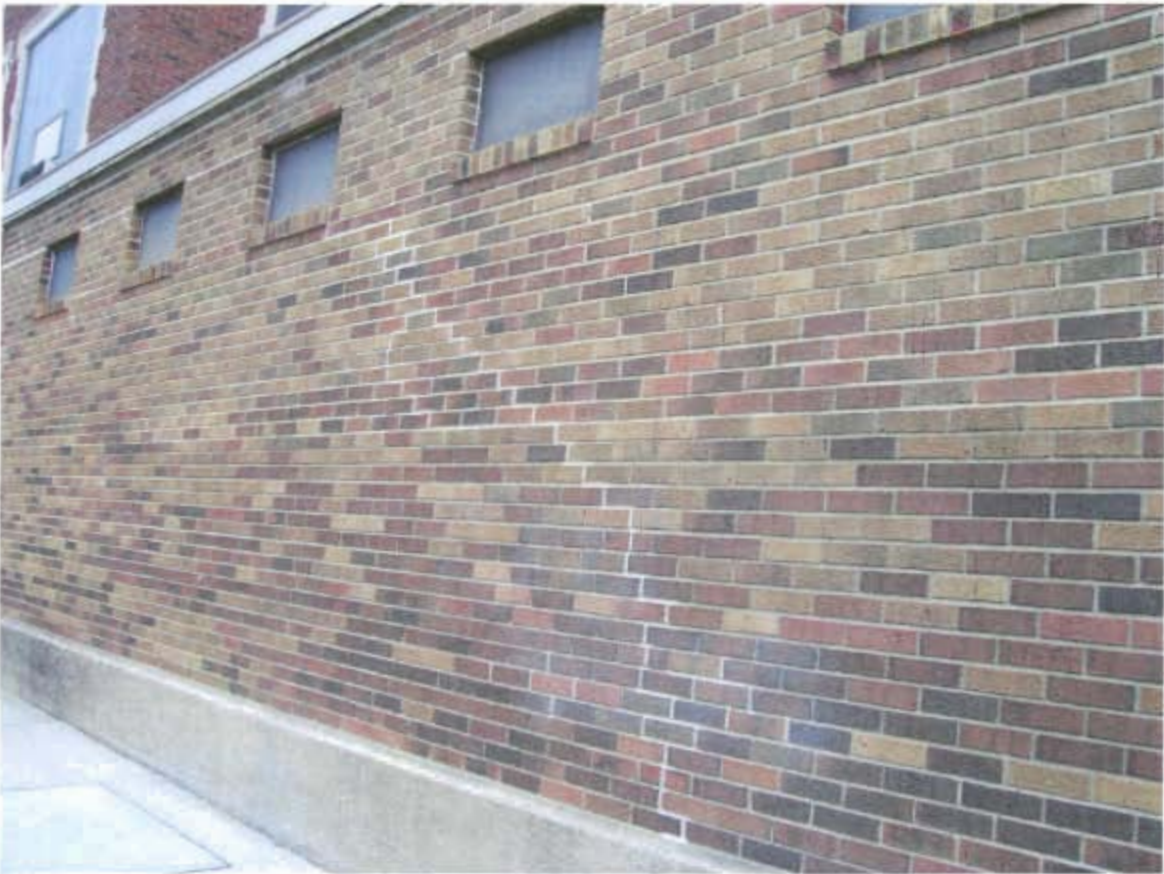
Photo #14: Previously repaired masonry crack at first floor locker rooms (now storage) at west wall.

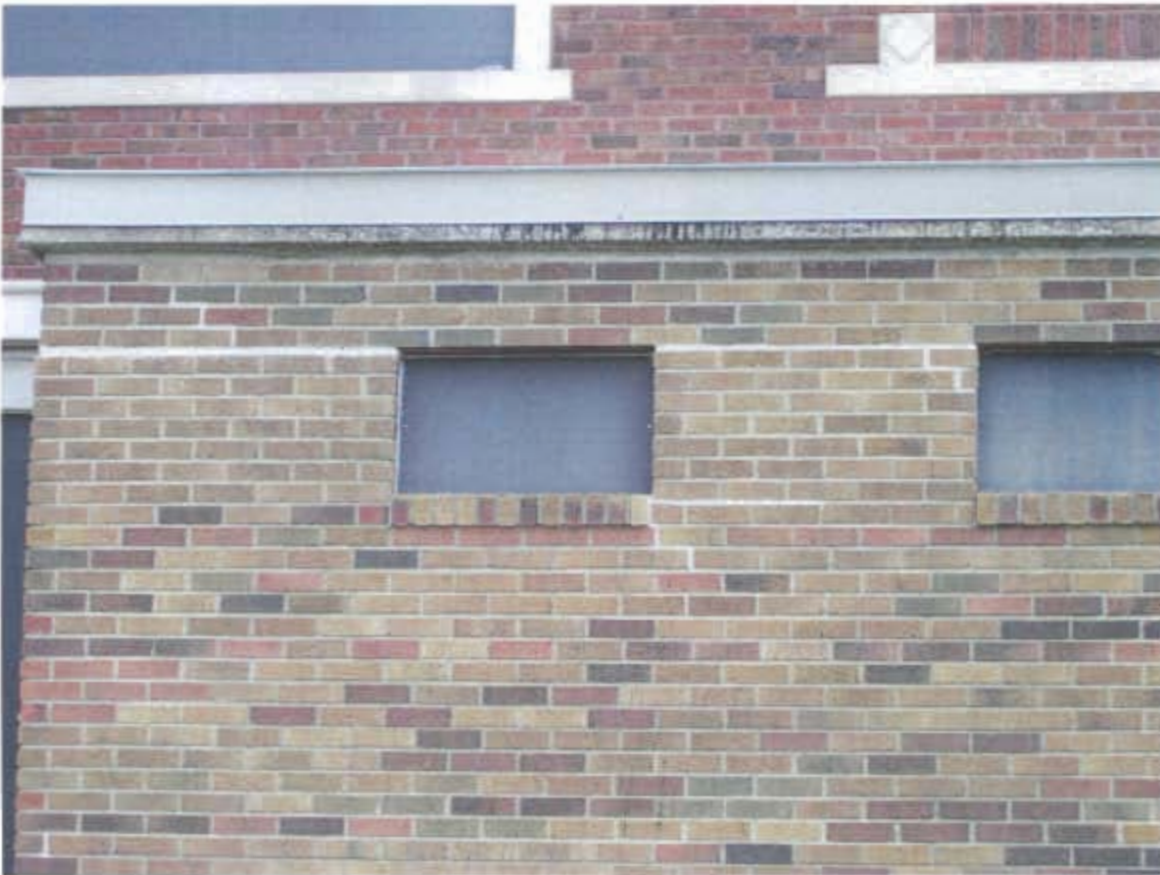
Photo #15: Previously repaired horizontal crack at west wall of locker rooms (now storage).

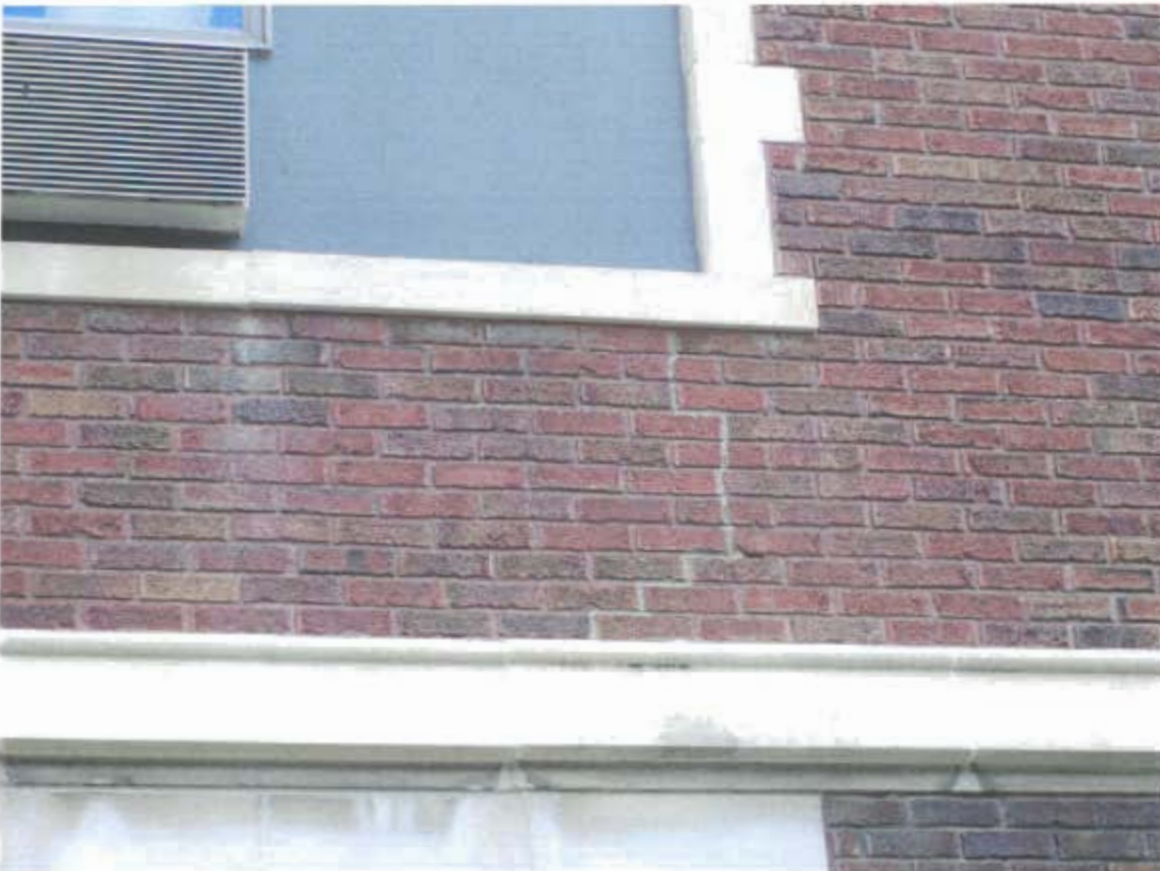
Photo #16: Previously repaired crack below second floor window.

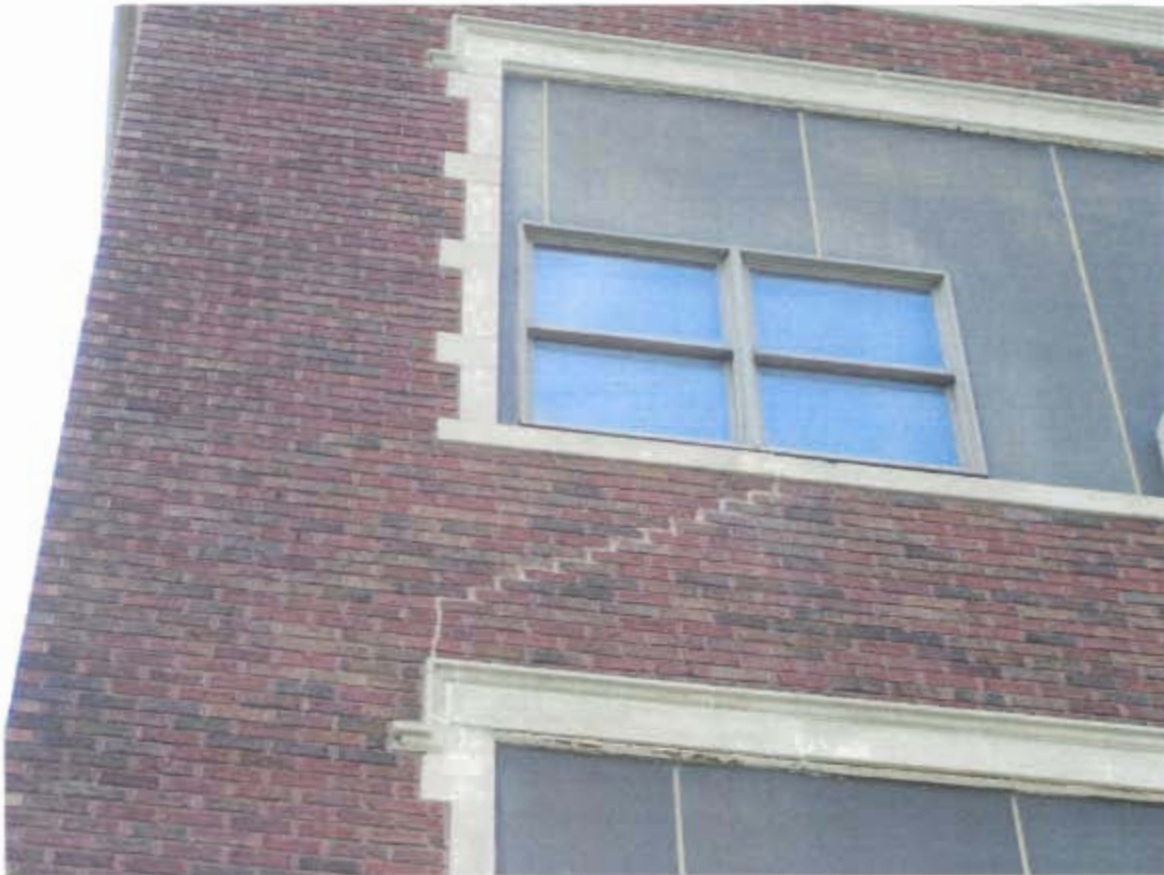
Photo #17: Previously repaired crack at east wall, south end; second floor window head to third floor sill.

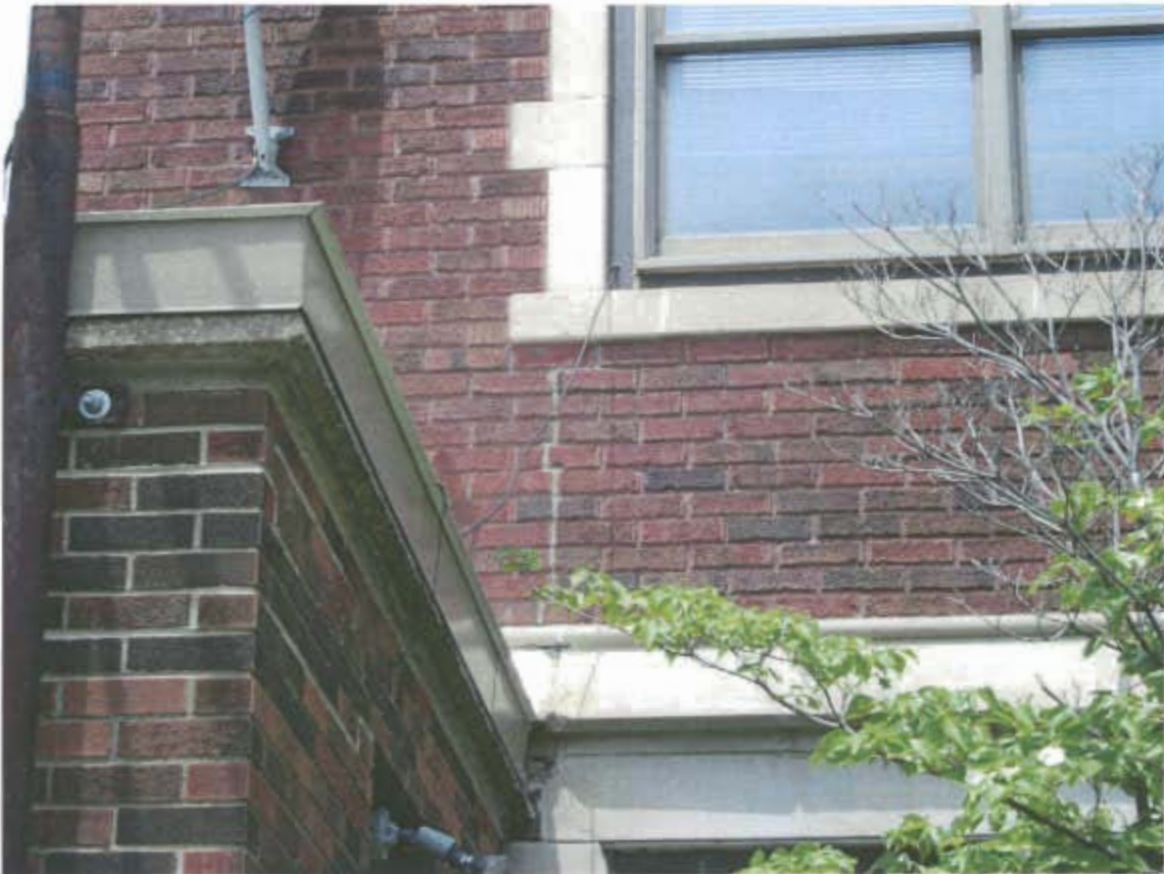
Photo #18: Previously repaired masonry crack at south wall, first to second floor.

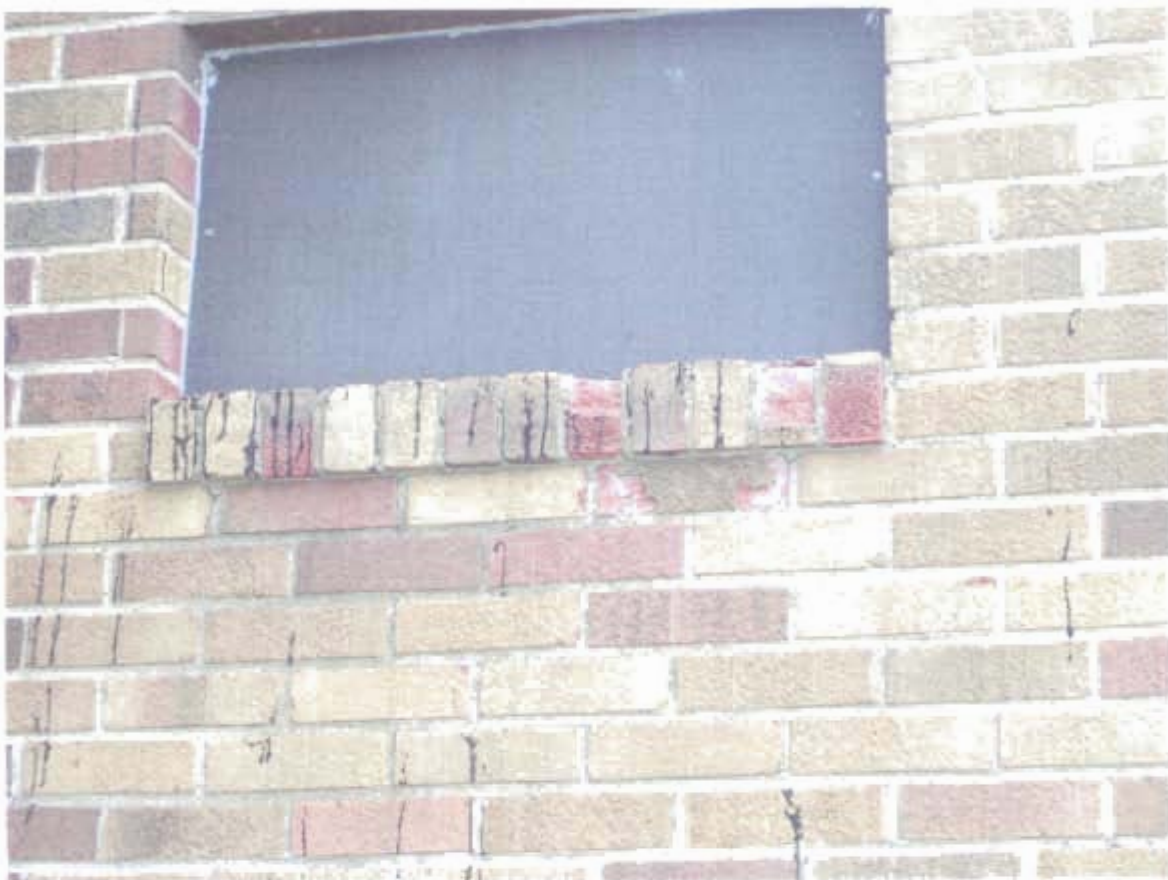
Photo #19: Brick spalling at north wall of locker rooms (now storage).

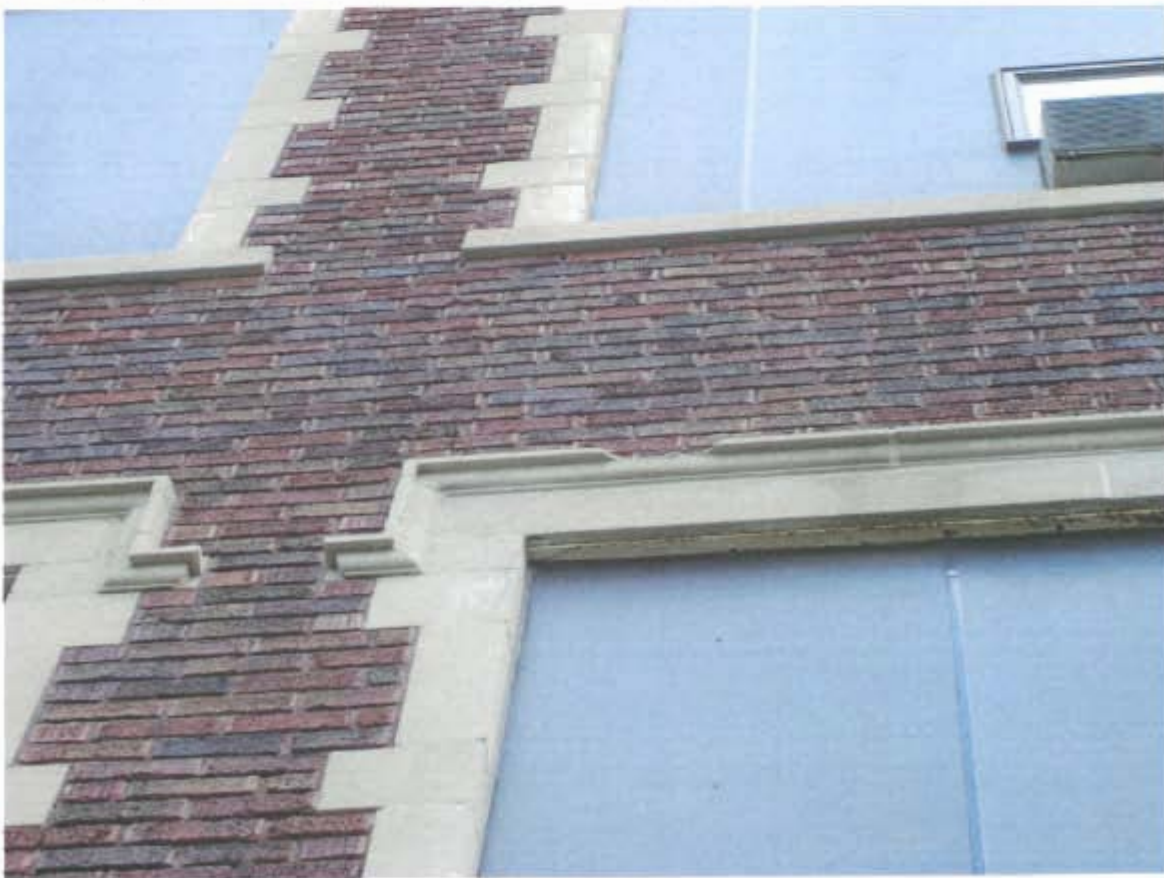
Photo #20: Damage to stone window header at east wall, second floor.

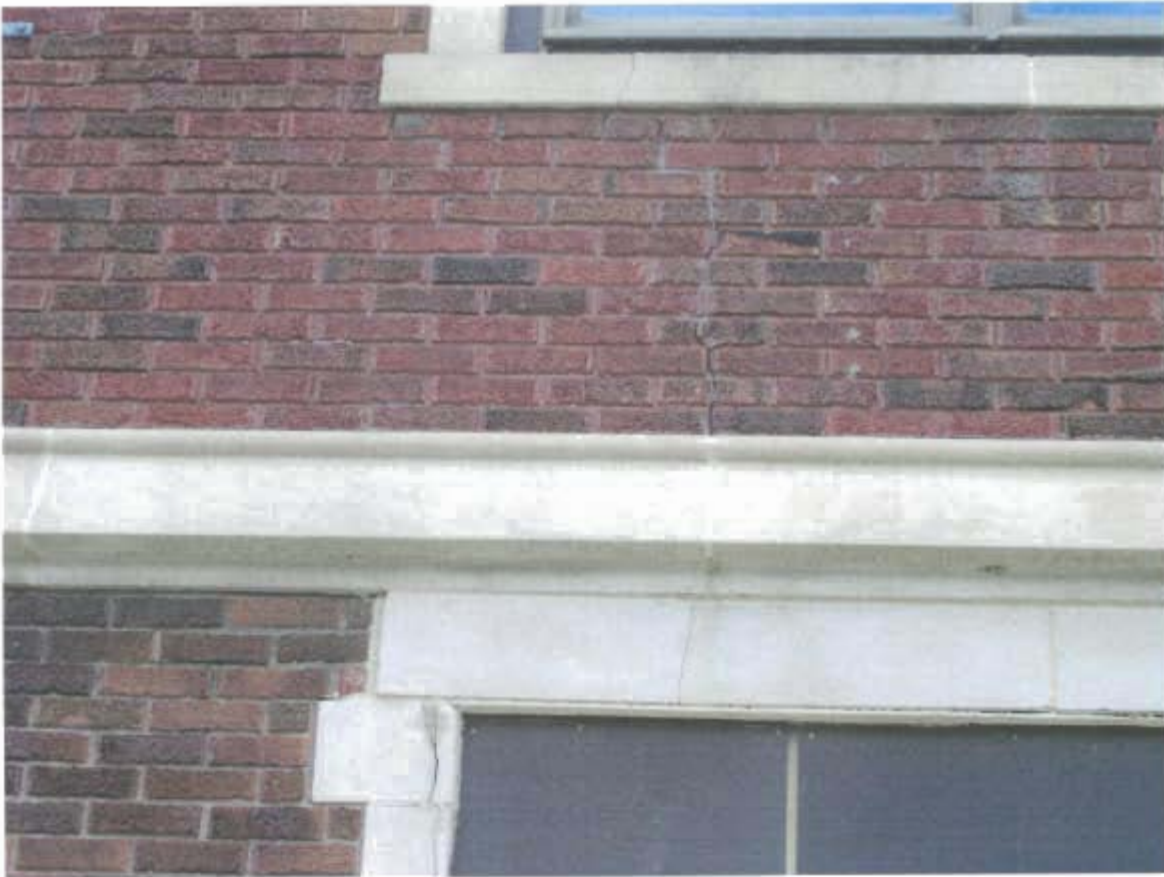
Photo #21: Crack in stone and masonry on east wall near south end. First floor window head to second floor sill.
